DEPARTMENT OF TRANSPORTATION

Contract #: 04-0120F4Cty: SF/ALA Rte: 80 PM: 13.2/13.9File #: 69.28**WELDING INSPECTION REPORT****Resident Engineer:**Siegenthaler, Peter**Address:** 333 Burma Road**City:** Oakland, CA 94607**Report No:** WIR-018976**Date Inspected:** 21-Dec-2010**Project Name:** SAS Superstructure**OSM Arrival Time:** 700**Prime Contractor:** American Bridge/Fluor Enterprises, a JV**OSM Departure Time:** 1900**Contractor:** Zhenhua Port Machinery Company, Ltd (ZPMC), Changxing Island **Location:** Shanghai, China**CWI Name:** Zhu Feng**CWI Present:** Yes No**Inspected CWI report:** Yes No N/A**Rod Oven in Use:** Yes No N/A**Electrode to specification:** Yes No N/A**Weld Procedures Followed:** Yes No N/A**Qualified Welders:** Yes No N/A**Verified Joint Fit-up:** Yes No N/A**Approved Drawings:** Yes No N/A**Approved WPS:** Yes No N/A**Delayed / Cancelled:** Yes No N/A**Bridge No:** 34-0006**Component:** TOWER & OBG Components**Summary of Items Observed:**

WELDING INSPECTION REPORT

TOWER LIFT-6, TOWER HEAD COMPONENT

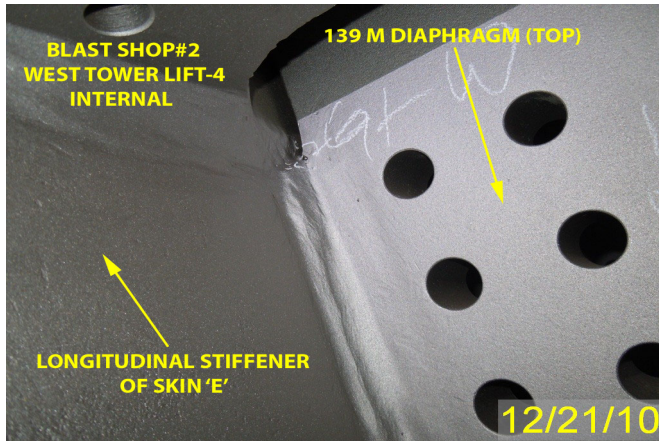
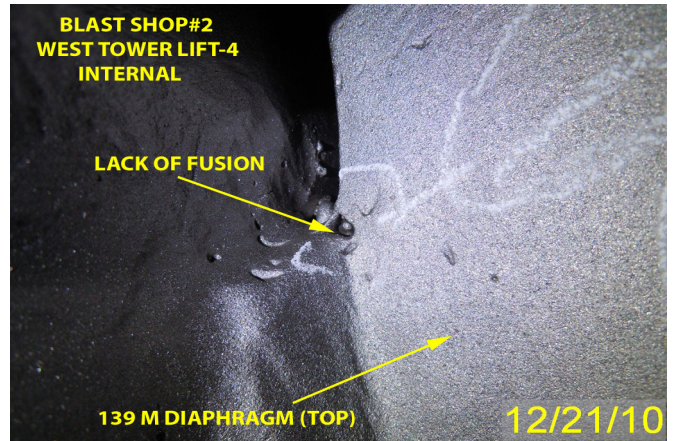
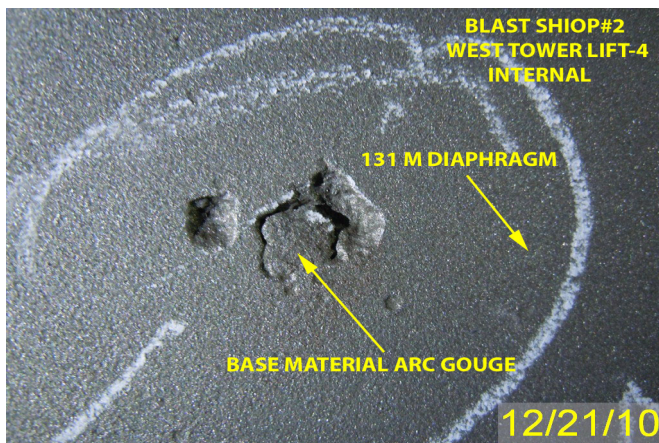
During the Internal post-blast visual inspection on West tower Lift-4 from 131 M diaphragm (TOP) to 146 M elevation, this Quality Assurance Inspector's (QA) discovered the defects required welding and Magnetic particle testing on weld and base material at the following locations:

- 1) Skin 'D' – Base material arc gouge –500 mm from top and 830 mm from D/E corner.
- 2) Skin 'C' – Base material arc gouge–On the edge of 1st stiffener from skin 'B' inside 143 M diaphragm.

- 3) Skin 'C' – Base material arc gouge–On the edge of 2nd stiffener from skin 'B' inside 143 M diaphragm.
- 4) Skin 'C' – Base material arc gouge–On the edge of 3rd stiffener from skin 'B' inside 143 M diaphragm.

- 5) Skin 'E' – Lack of fusion –Diaphragm to stiffener weld (1st from skin 'D') at 139 M diaphragm (TOP).
- 6) Skin 'E' – Underfill – Diaphragm to fit-lug weld (1st from skin 'A') 139 M diaphragm (TOP).

- 7) Skin 'A' – Base material arc gouge – at 139 m diaphragm (bottom) close to skin 'E' 1st stiffener.
- 8) Skin 'E' – Base material arc gouge – edge of the 1st stiffener from skin 'D' and 400 mm from 135 M diaphragm (top).

- 9) Skin 'E' – Under fill – diaphragm to skin weld close to A/E corner at 135 M diaphragm (top).
- 10) Skin 'A' – Base material arc gouge – close to 1st stiffener from skin 'D' at 131 M diaphragm (top).

For further information, please see the attached pictures below.
